CASE STUDY: INVESTIGATING A RAIL ROLLOVER DERAILMENT

FRA Track Safety Symposium
St. Louis, MO
April 6, 2022

Brad Kerchof
Advanced Rail Management
Norfolk Southern Railway (retired)

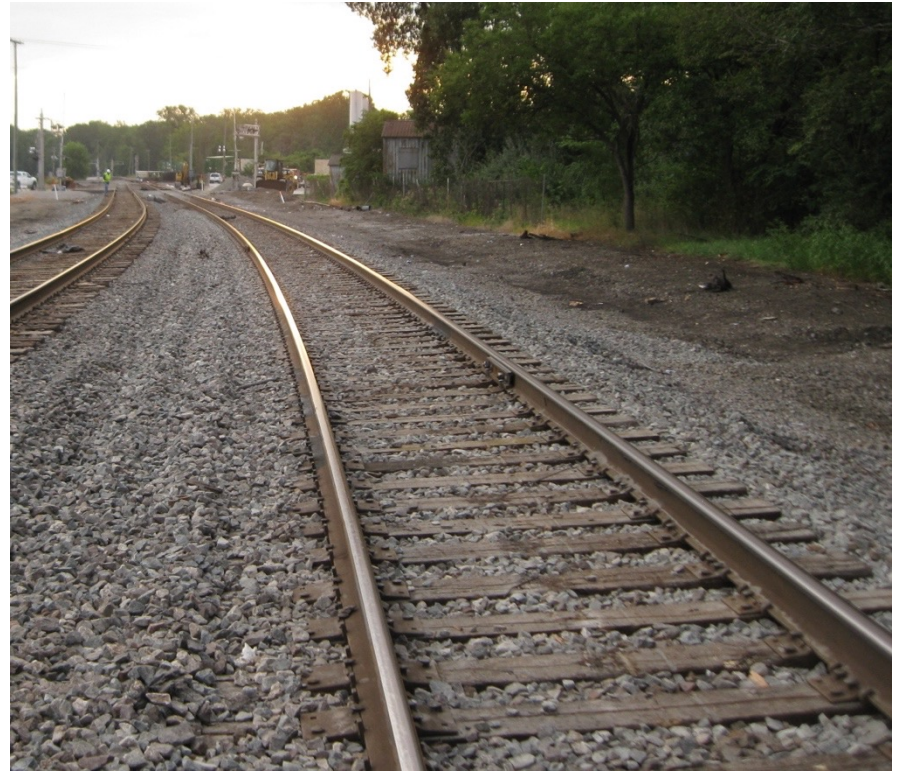
Looking from POD east, in direction of train movement (after post-derailment trackwork)

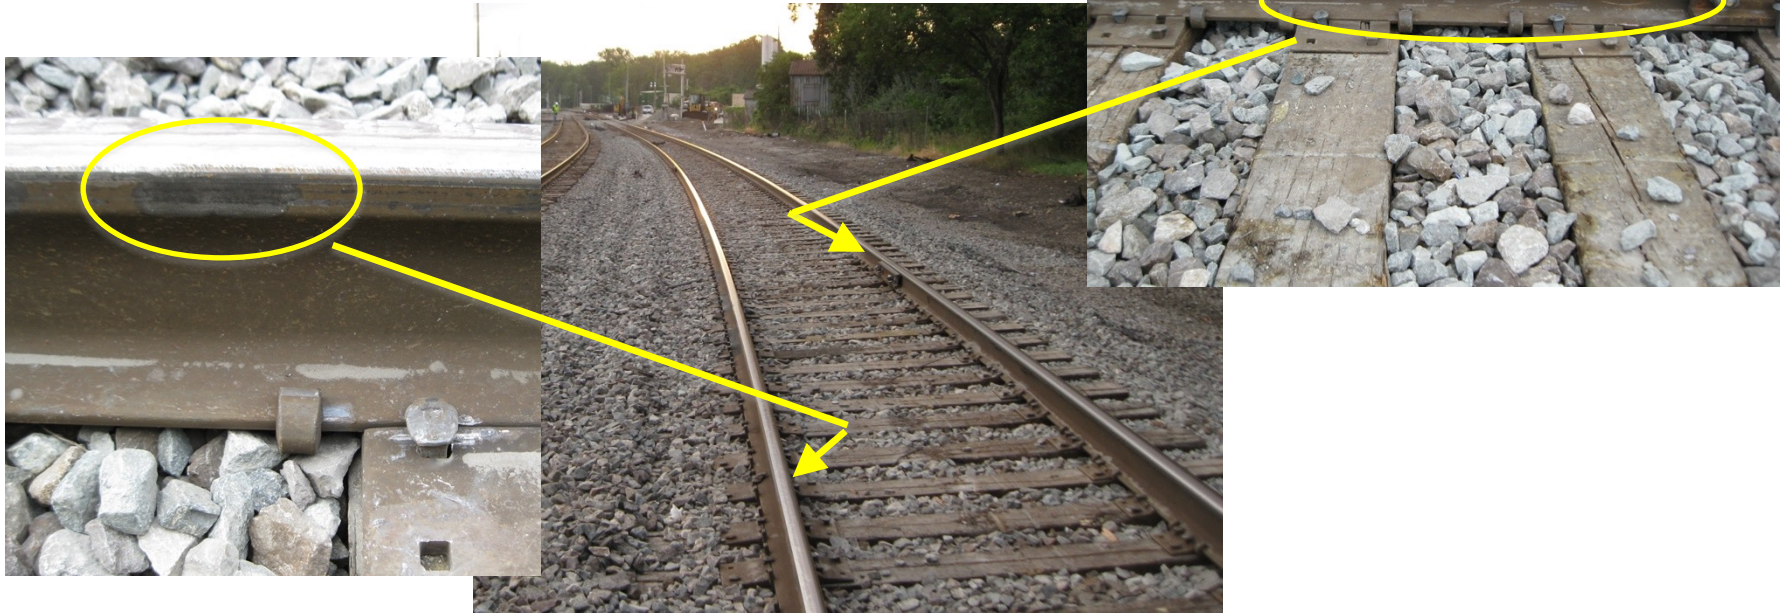
The derailment committee identified an area where a low-side wheel dropped in and the high rail showed a flange mark on the web.

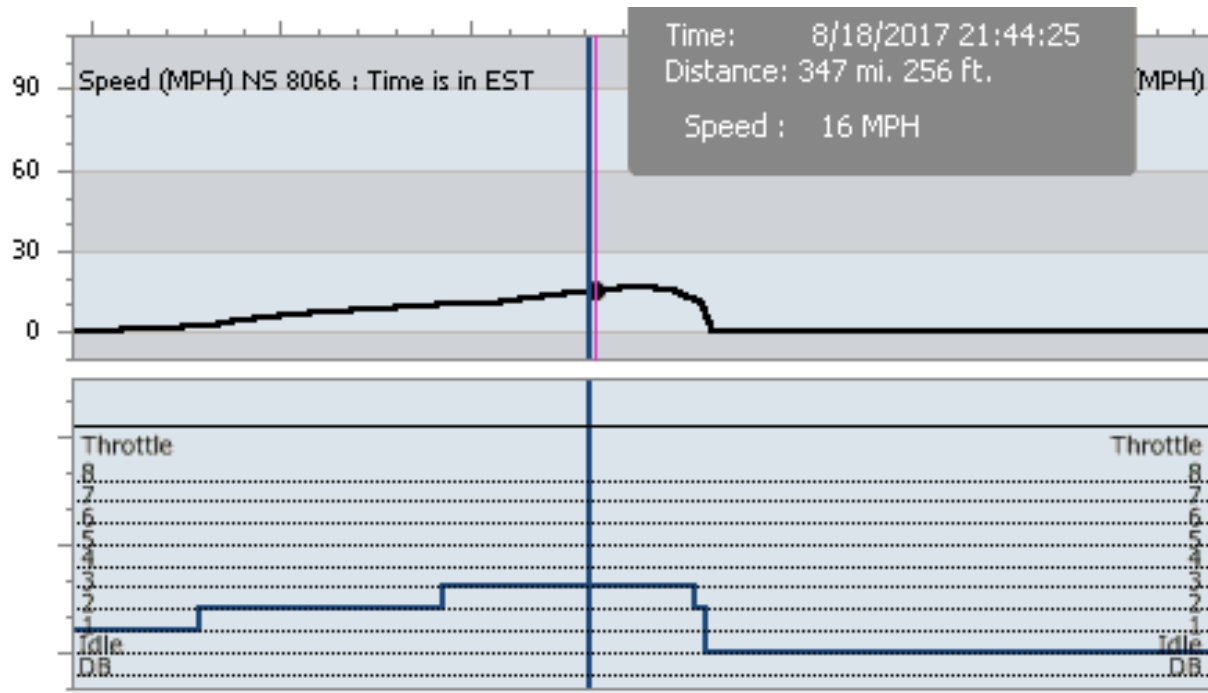
- The cursor marks when the lead locomotive was just east of Hartzell Rd.
- Speed was 16 mph and climbing gradually.
- Throttle was in notch 3.

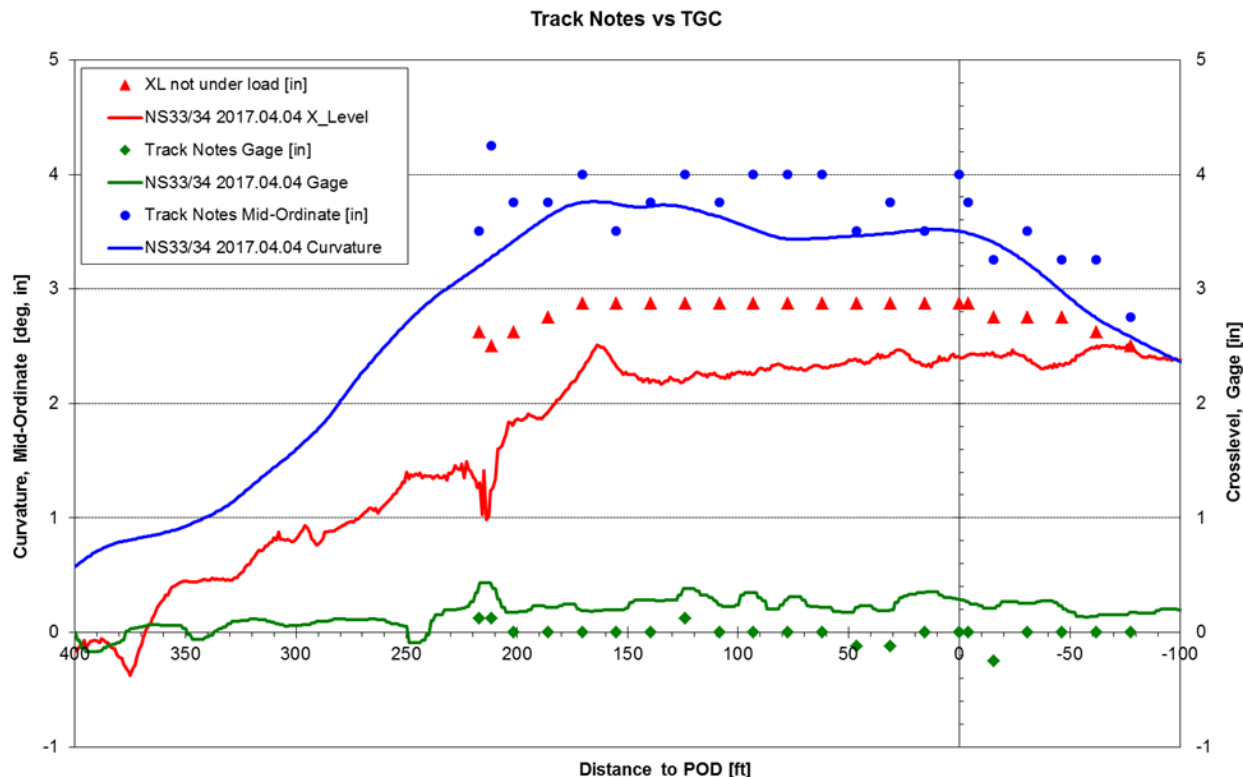
Curvature – left axis

X-level and gage – right axis

“0” on horizontal axis marks the POD.

Points: Gage, alignment & crosslevel from derailment track notes (Aug 18, 2017)

Lines: Same parameters from April 4, 2017 track geometry car test

Conclusion: line, surface and gage all look good!

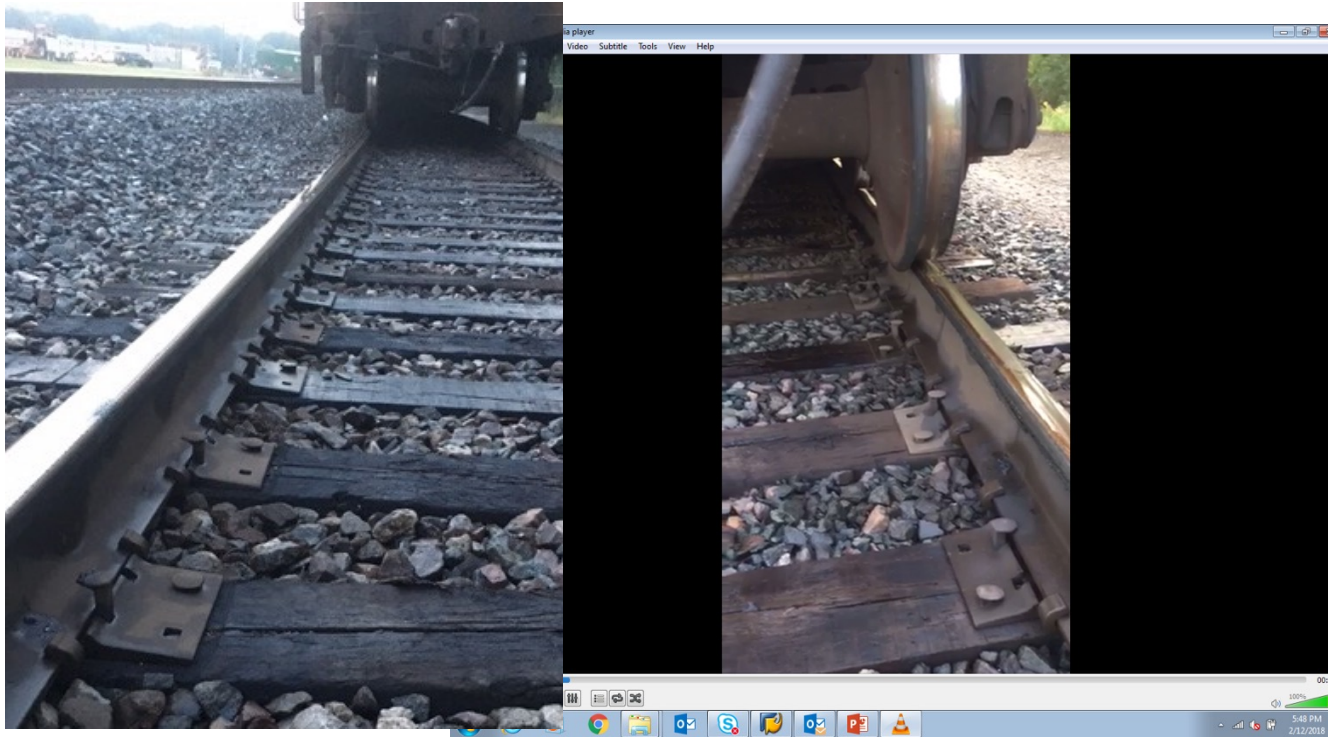
This wheelset is under the trail truck of last derailed car. This truck stopped short of the POD

Low rail on left

High rail on right

Note raised spikes on both rails

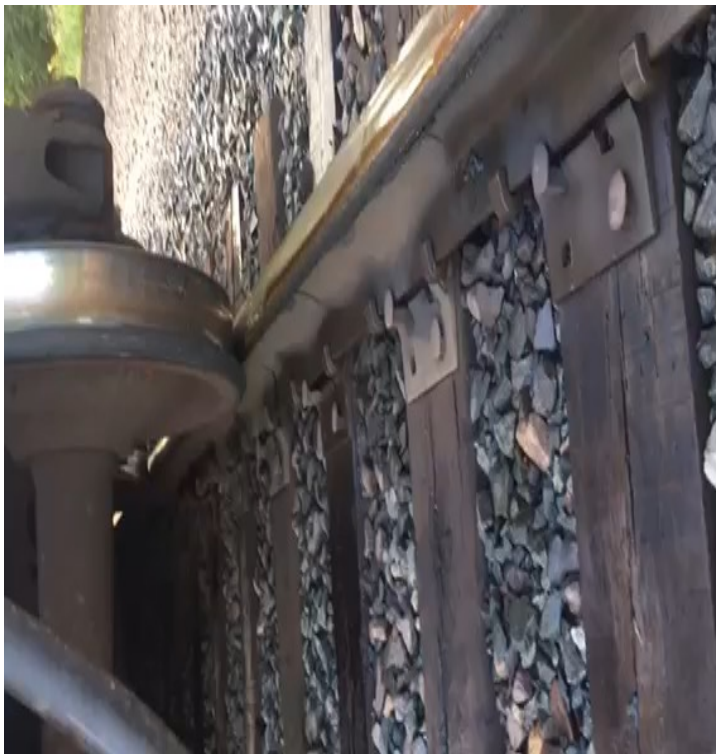
- High rail - spikes lifted for a short distance prior to POD.
- Low rail - spikes lifted for a longer distance prior to POD.

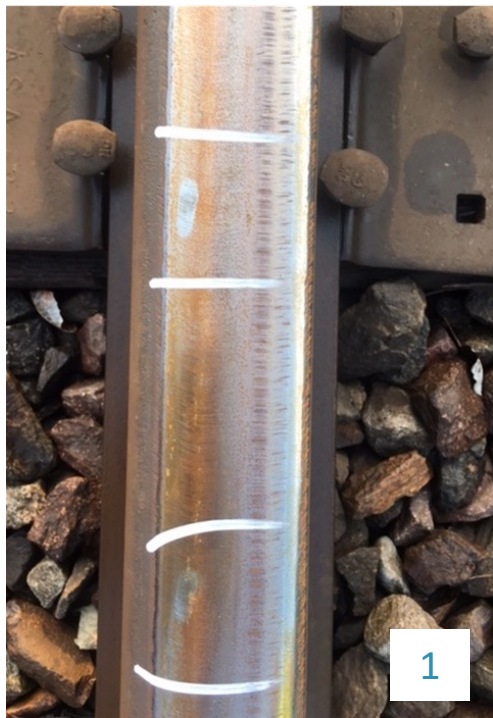
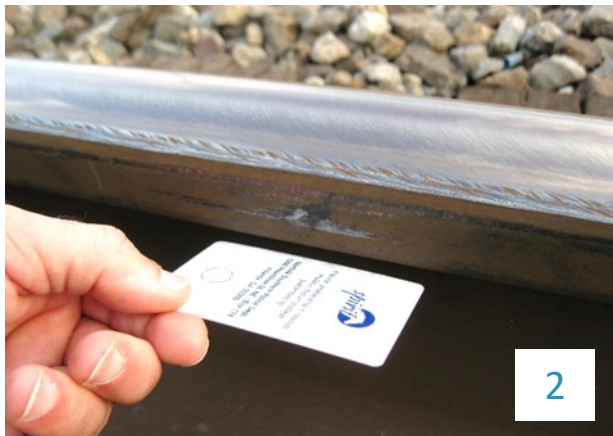
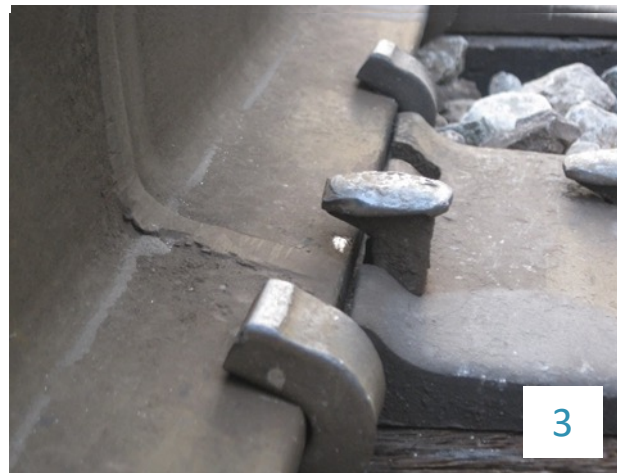
Three unusual conditions were noted on the low rail prior to the POD:

1. Scuff marks on field side of the head
2. Wheel flange contact on the gage face
3. Evidence that rail had been canting out under load

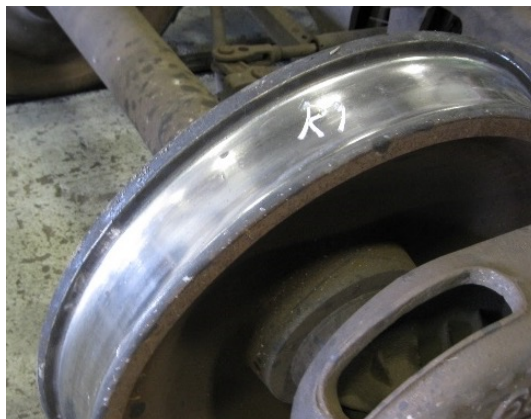
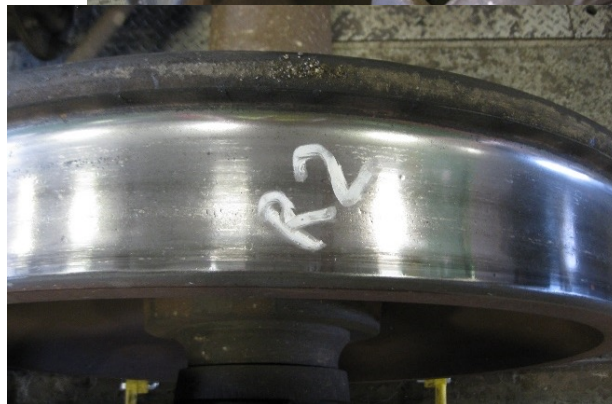
R1 showed several white marks on the flange. During a car shop inspection, however, no evidence was found on the tread or flange tip that indicated that the wheel had been on the ground.

None of the other wheel treads or flanges showed evidence of derailment damage.

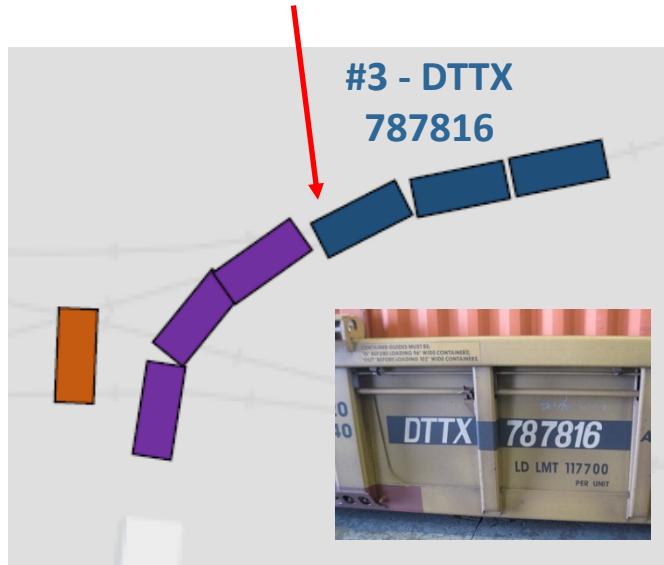
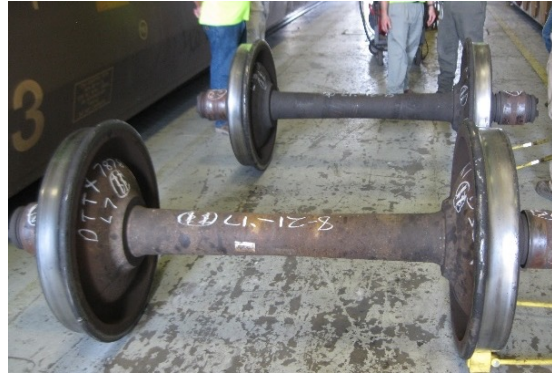
The first derailed wheels were under the trail truck of the 3rd car.

These wheels show some flange contact with the ground, but not enough to have been the first to derail (they would have run over 2 turnouts and a diamond).

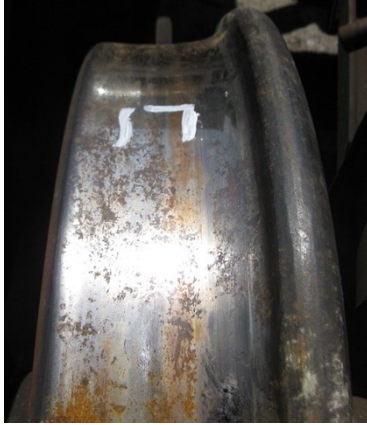
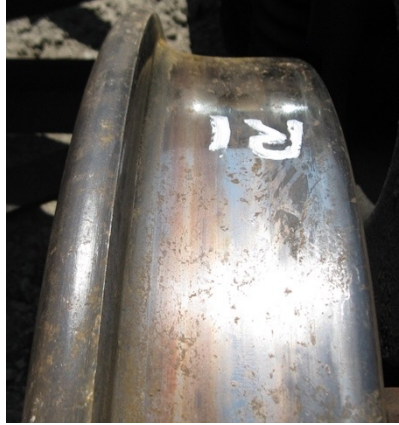
L1 and R1 showed minimal damage

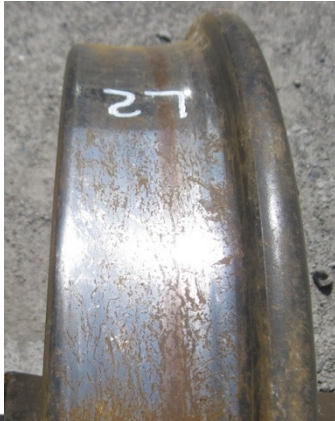
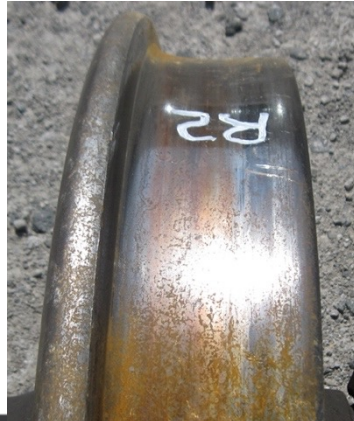
L2 and R2 also showed minimal damage

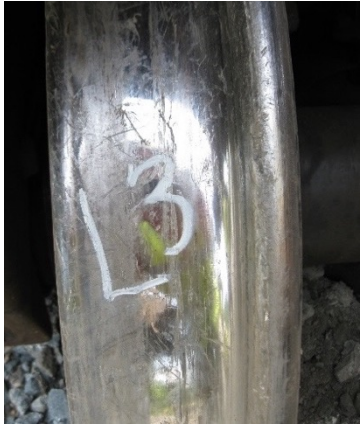
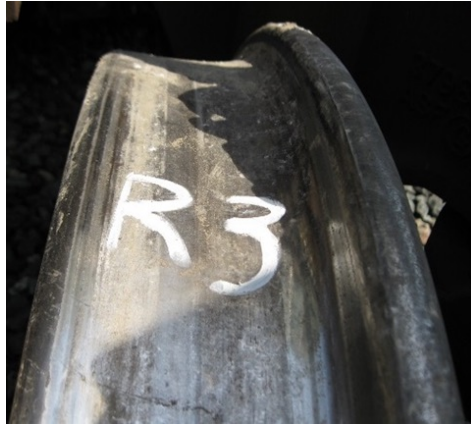
L3 and R3 showed moderate damage.

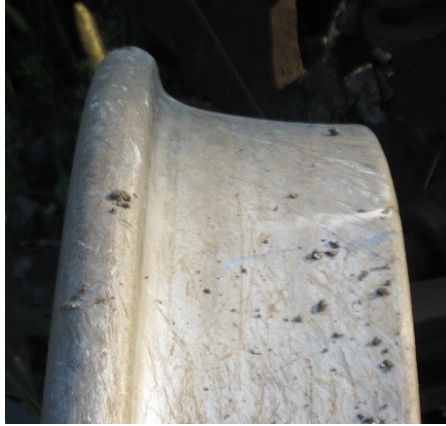
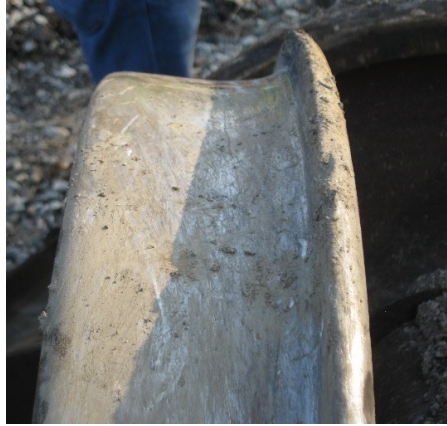
L5 & R5

Note asymmetric wear – each axle has a wheel with a worn flange and hollow tread, and a wheel with a full flange and normal tread.

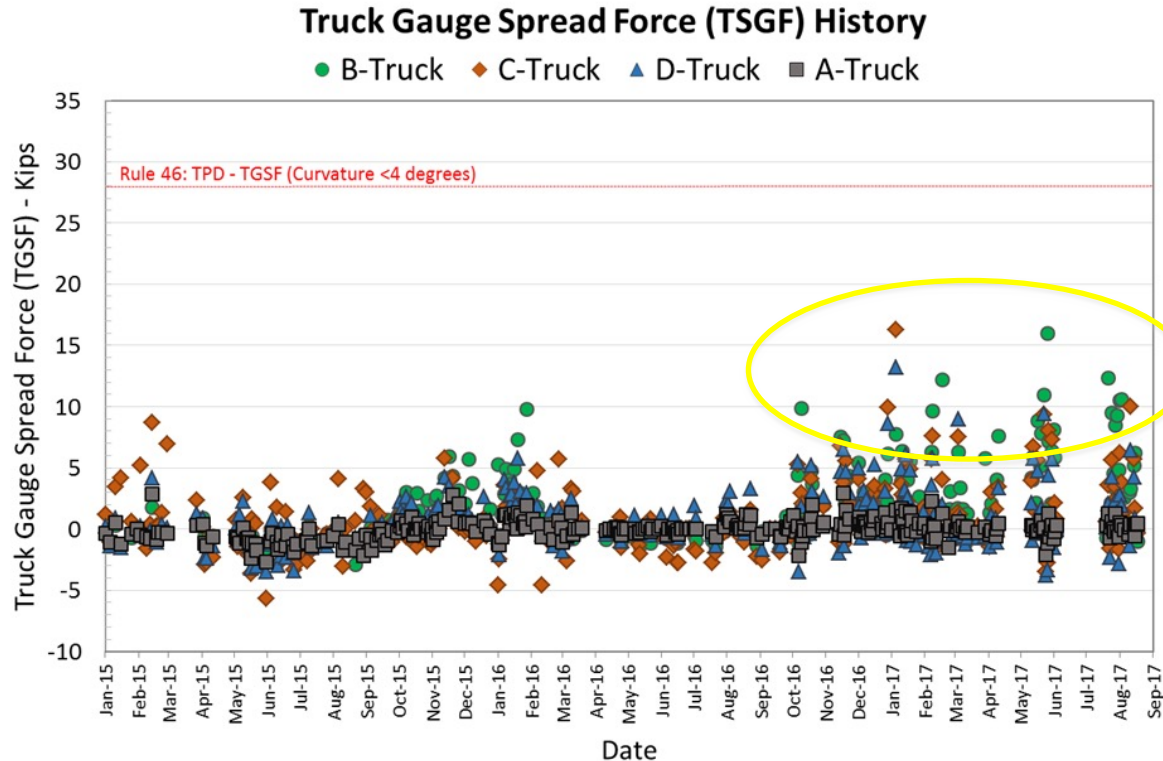
Gage-spreading force = sum of lateral wheel forces.

B and C trucks, and to some extent D truck, became elevated on a sustained basis in late 2016.

This plot does not differentiate by leading end or load/empty status.

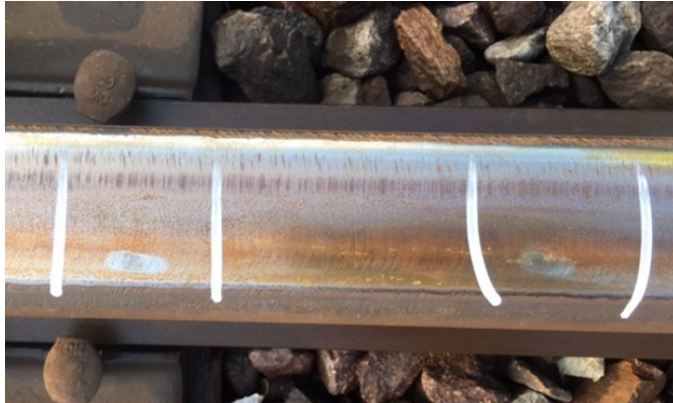
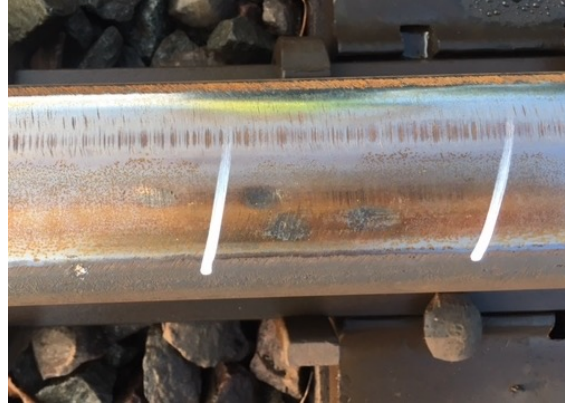
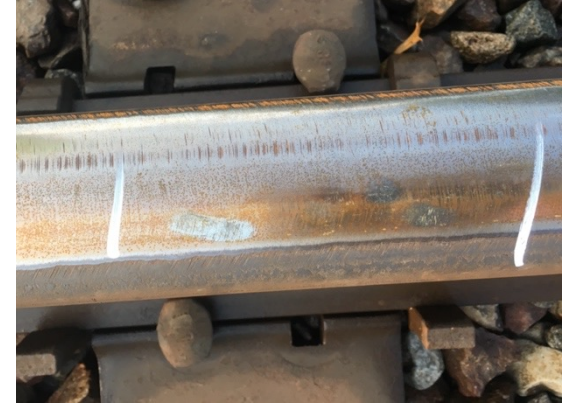
The field side of the low rail showed a series of scuff marks from beginning of curve to the POD

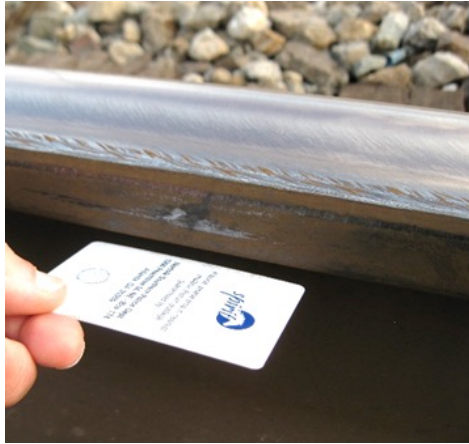
Station 16

The low rail gage face showed evidence of wheel flange contact from the beginning of the curve to the POD.

In order for wheel flanges to contact the gage face of a low rail, the rail must be canted out!

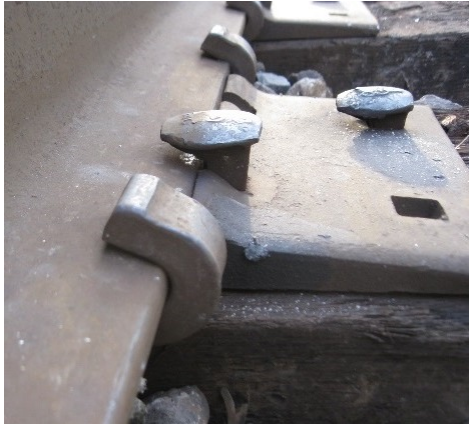
Derailment Station 16
(15' - 6" spacing)

The low rail showed additional evidence of dynamic cant from beginning of the curve to the POD.

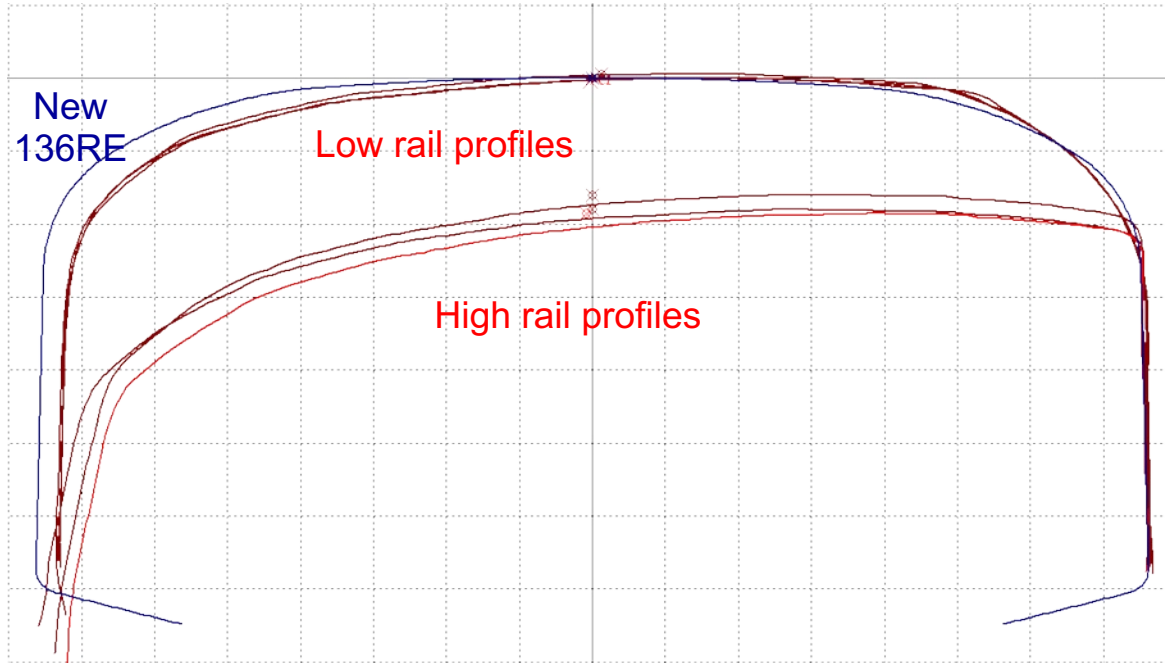
High and low rail profiles from 3 locations in the full body (gage is on right).

The blue line is new 136RE.

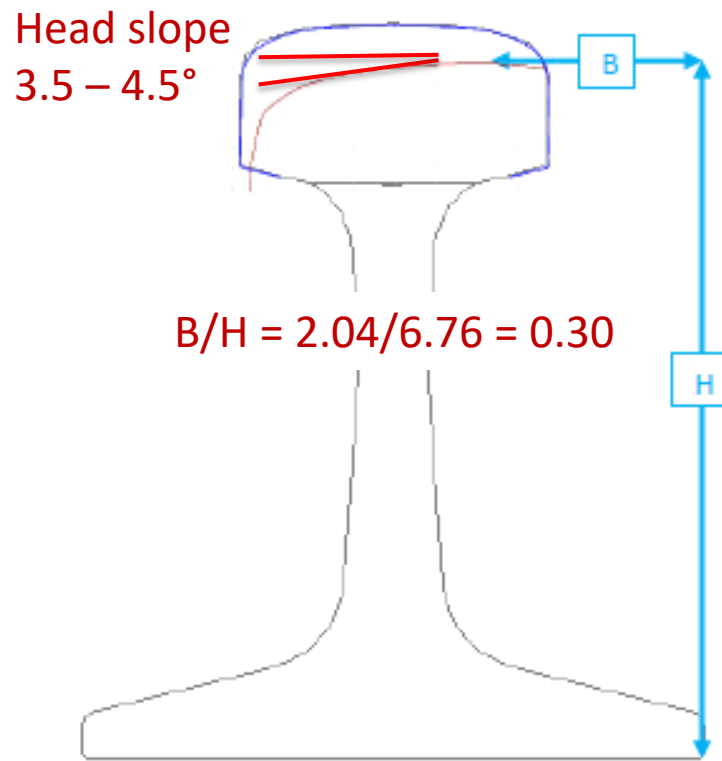
High rail profile from near POD

A B/H ratio of 0.30 means that the truckside L/V ratio need only exceed 0.30 to initiate rail roll!

Actual wheel contact location is influenced by B/H, head slope, rail cant and wheel profile.

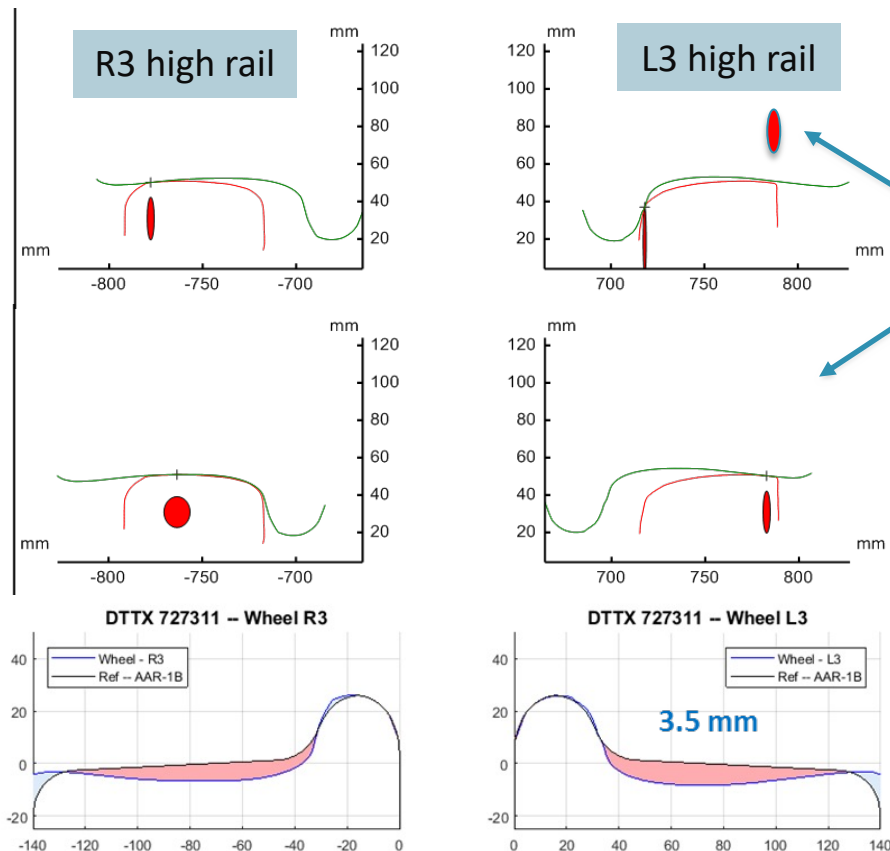
In all tracking positions – from high rail flanging to low rail flanging, the L3 wheel always contacts the field edge of the high rail. (Field side contact is typical of tread-hollow wheels.)

Consequences of this type of contact:

- ▶ high gage-spreading forces
- ▶ low B/H rail stability

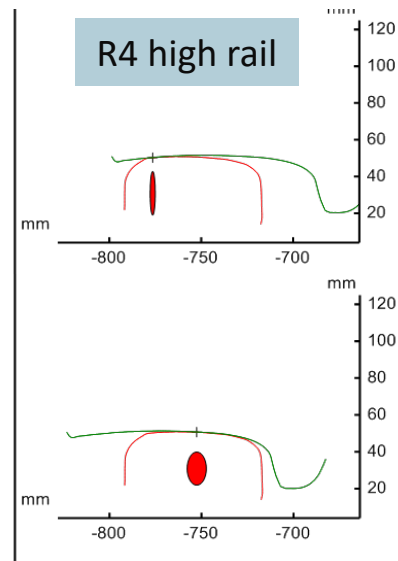
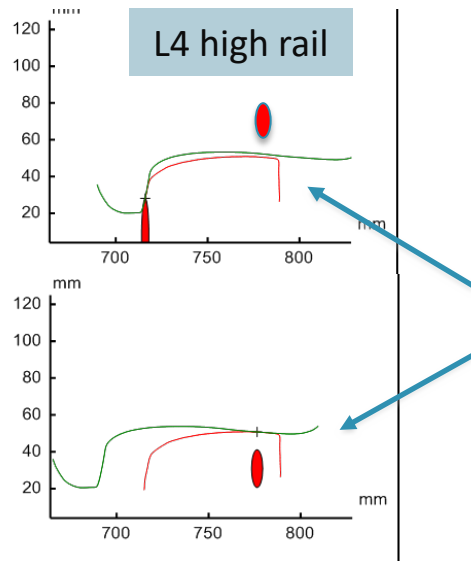
Like the L3, the L4 wheel always contacts the high rail on the field edge, no matter what the tracking position.

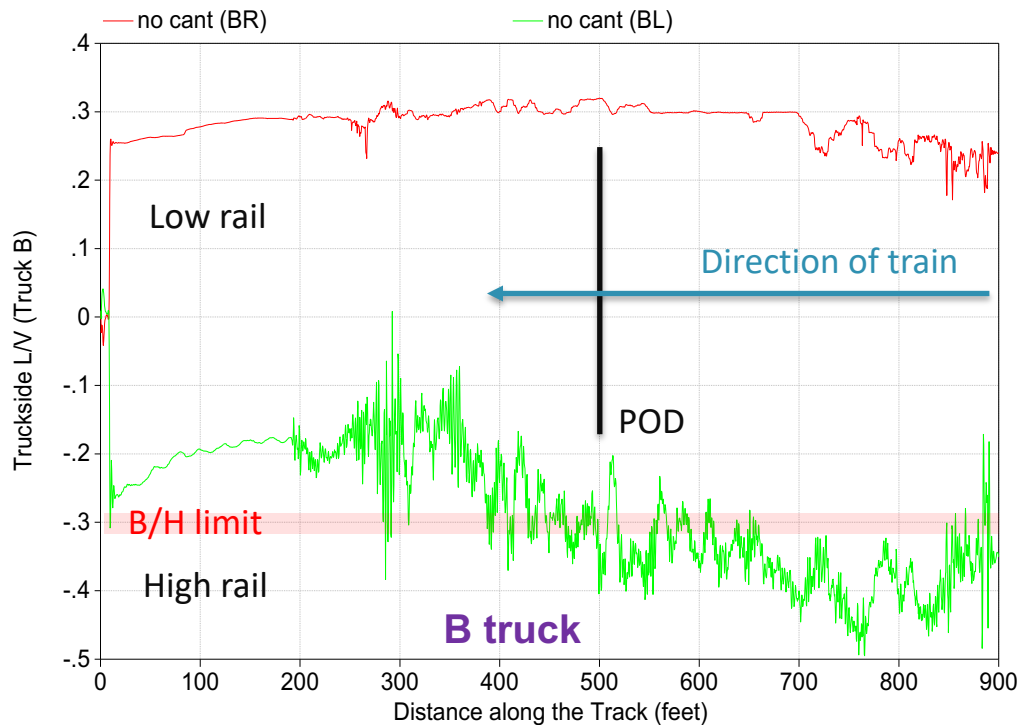
POD located at 500 feet

High rail L/V reaches 0.40 in the vicinity of the POD. But the rail hasn't rolled over yet!

How do we know?
Minimal damage to the B truck wheels

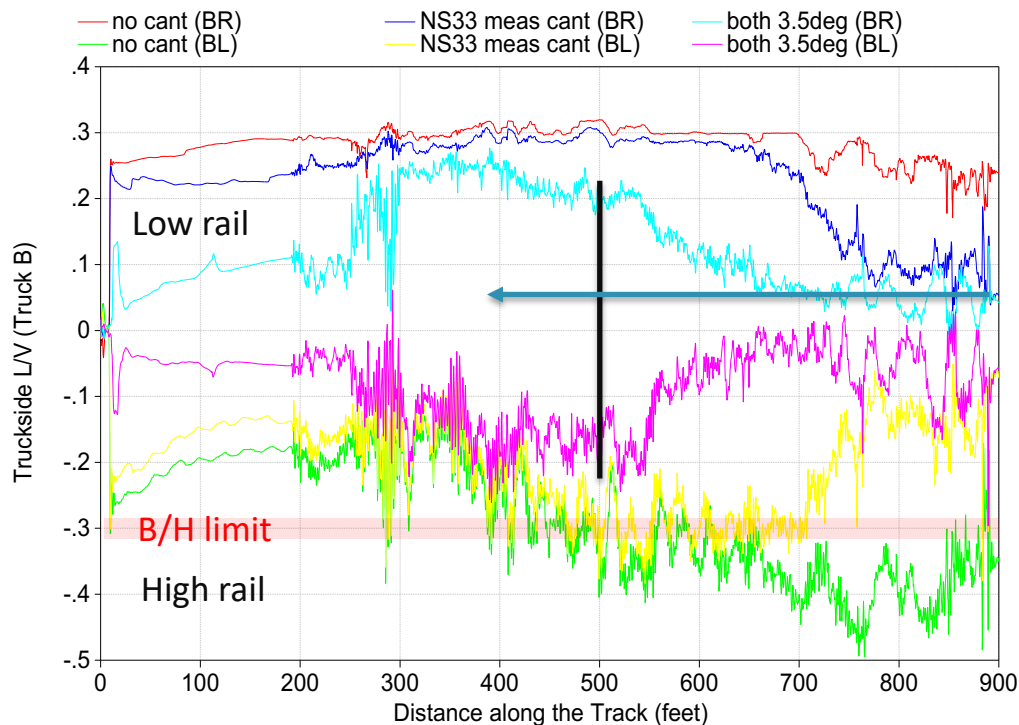
- red & green => no cant
- blue & yellow => cant 0.5° high rail, 1.0° low rail (from April 2017 geo car)
- cyan & pink => 3.5° cant both rails (amount indicated by spike lift)

As cant increases, truckside L/V decreases!

There would likely be no derailment if B truck were the only consideration.

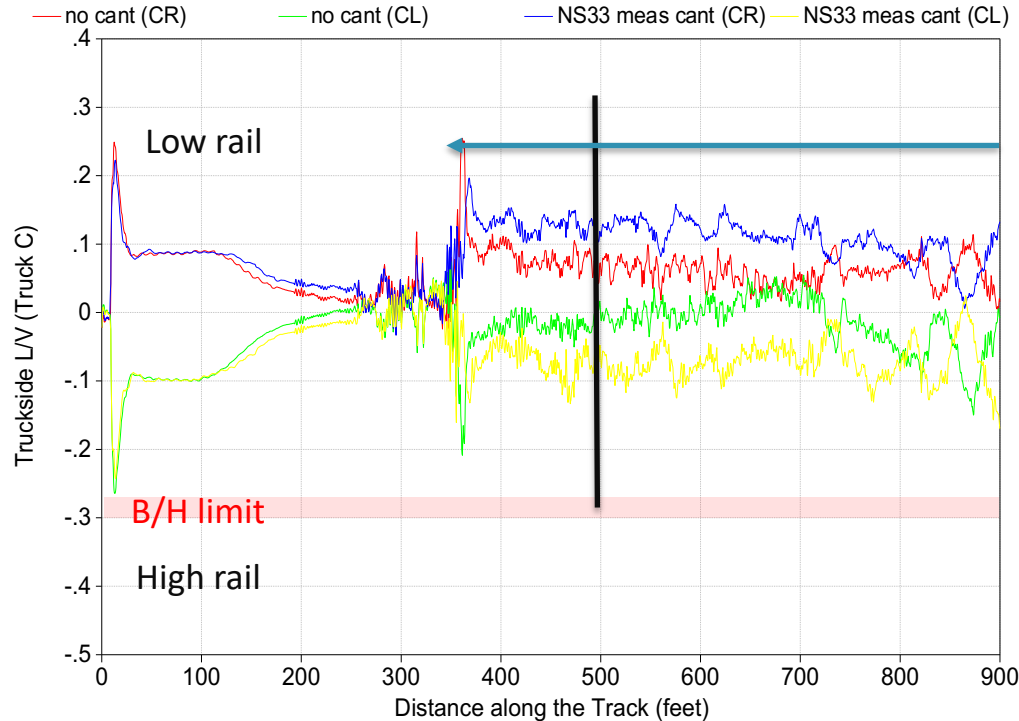
- red & green => no cant
- blue & yellow => cant 0.5° high rail, 1.0° low rail (from April 2017 geo car)

As cant increases, truckside L/V also increases

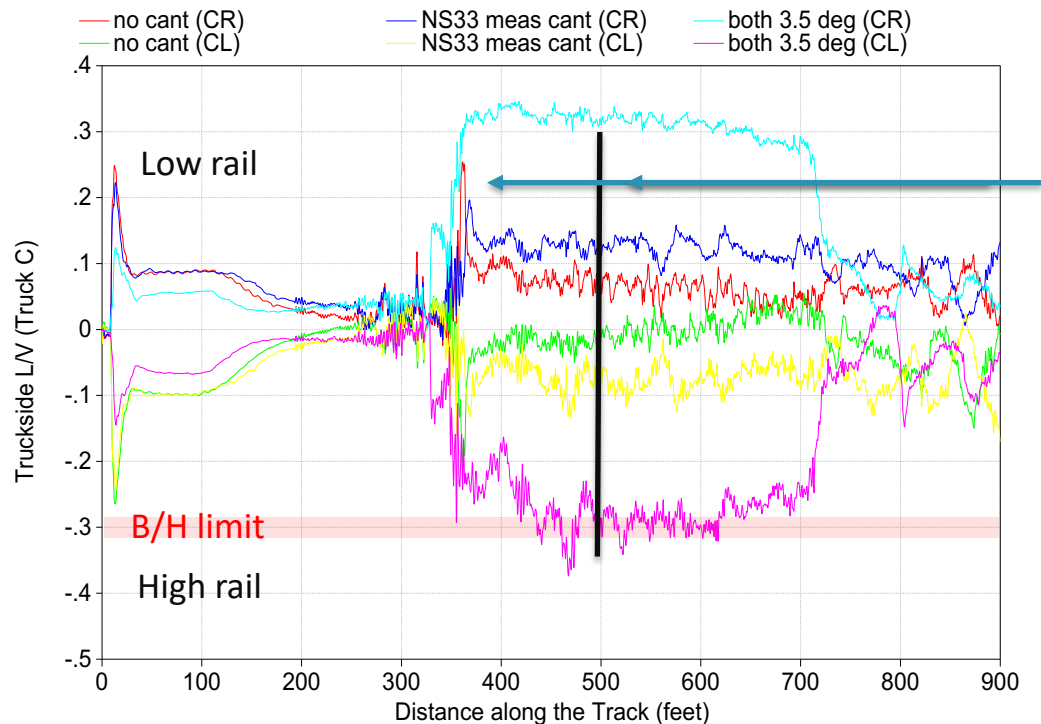
- red & green => no cant
- blue & yellow => cant 0.5° high rail, 1.0° low rail (from April 2017 geo car)
- cyan & pink => 3.5° cant both rails (the amount indicated by spike lift)

As cant increases, truckside L/V also increases, reaching a high rail L/V close to 0.35. This is self-driving behavior - as cant increases, B/H diminishes!

Conclusion: B truck initiated high rail cant, and then C truck rolled the rail over.

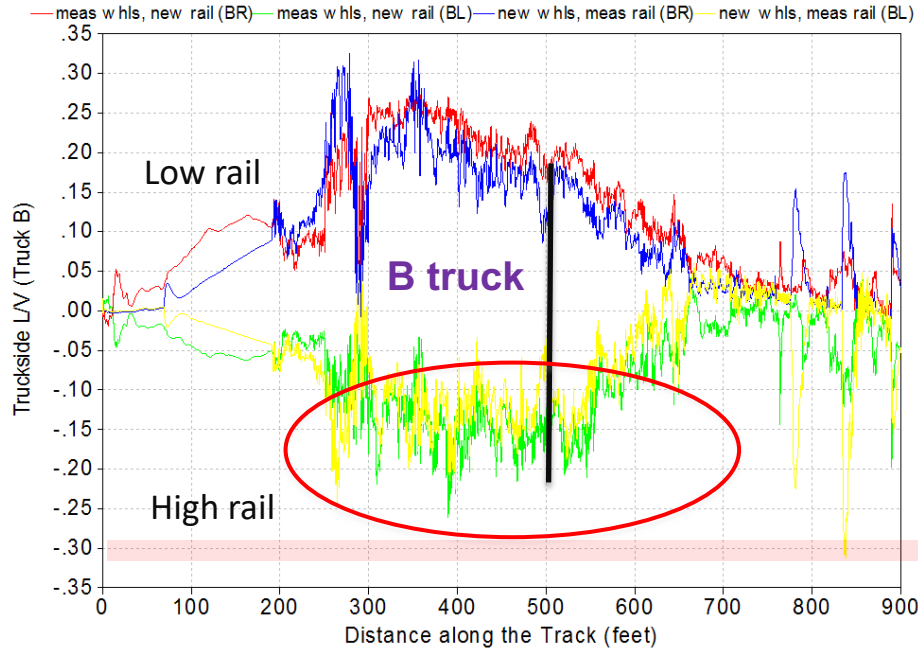
Red / green => worn wheels on new rail are = to
Blue / yellow => new wheels on worn rail

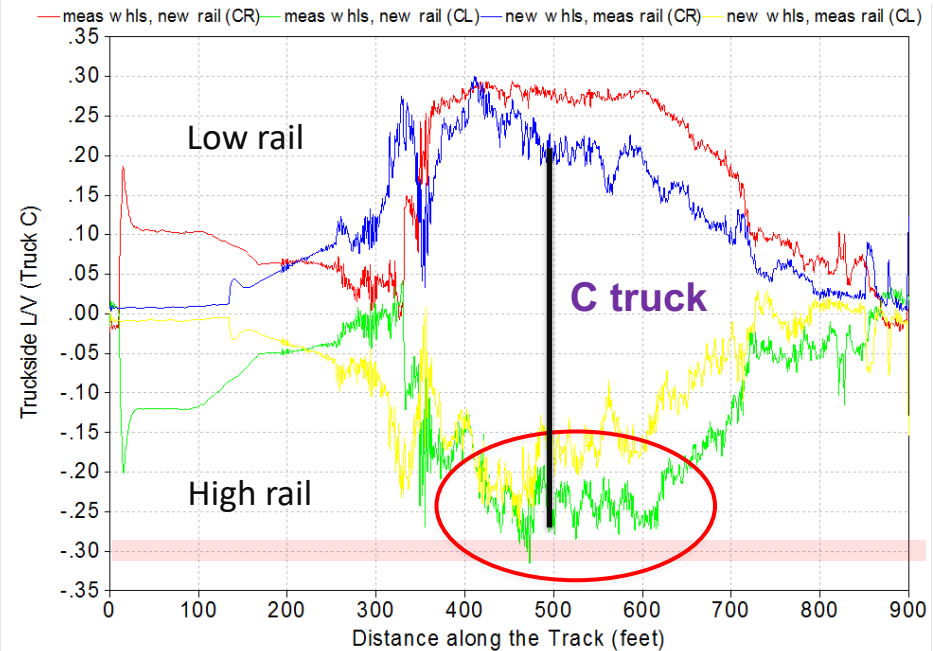
Red / green => worn wheels on new rail are > than
Blue / yellow => new wheels on worn rail

Based on the truckside L/V ratios predicted by VAMPIRE, and the fact that the worn wheel profile had a greater impact than the worn rail profile:

“High rail rolled out under lead and intermediate trucks of loaded articulated doublestack DTTX 727311 account significantly hollow (but non-defective) wheel profiles operating on a high rail in a 3.5° curve with moderate head slope and low B/H.”
